# THE COLORADO WICKIUP PROJECT PHASE VII:

## DOCUMENTATION OF SELECTED EPHEMERAL WOODEN FEATURE SITES IN ROCKY MOUNTAIN NATIONAL PARK, COLORADO

Completed for  
The Colorado Historical Society  
State Historical Fund Project No. 2011-M1-020  
and  
The National Park Service

DARG Project # D1003  
June 8, 2012

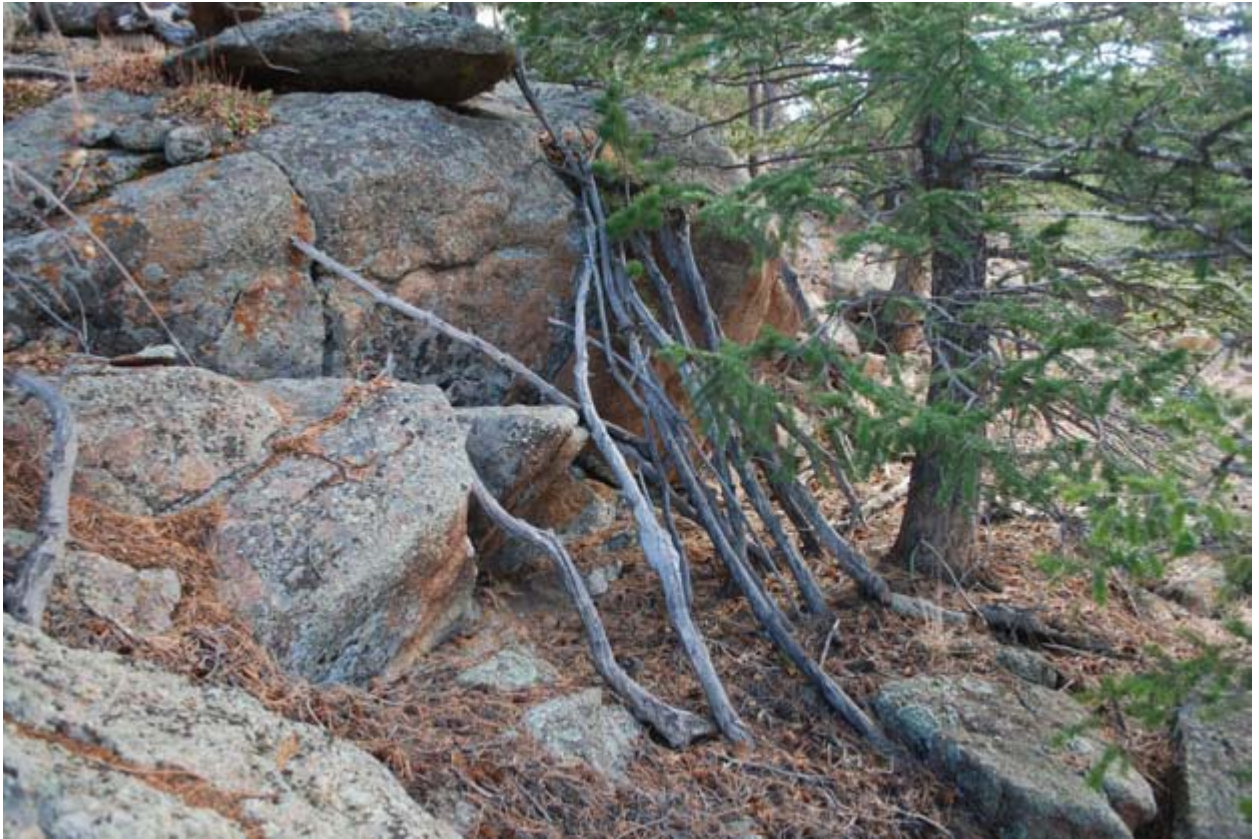
**Plate 1**

Feature A, boulder lean-to, at 5LR4460, the Hidden Valley Wickiups site,  
looking east-southeast (Photo D1003, 1-21).

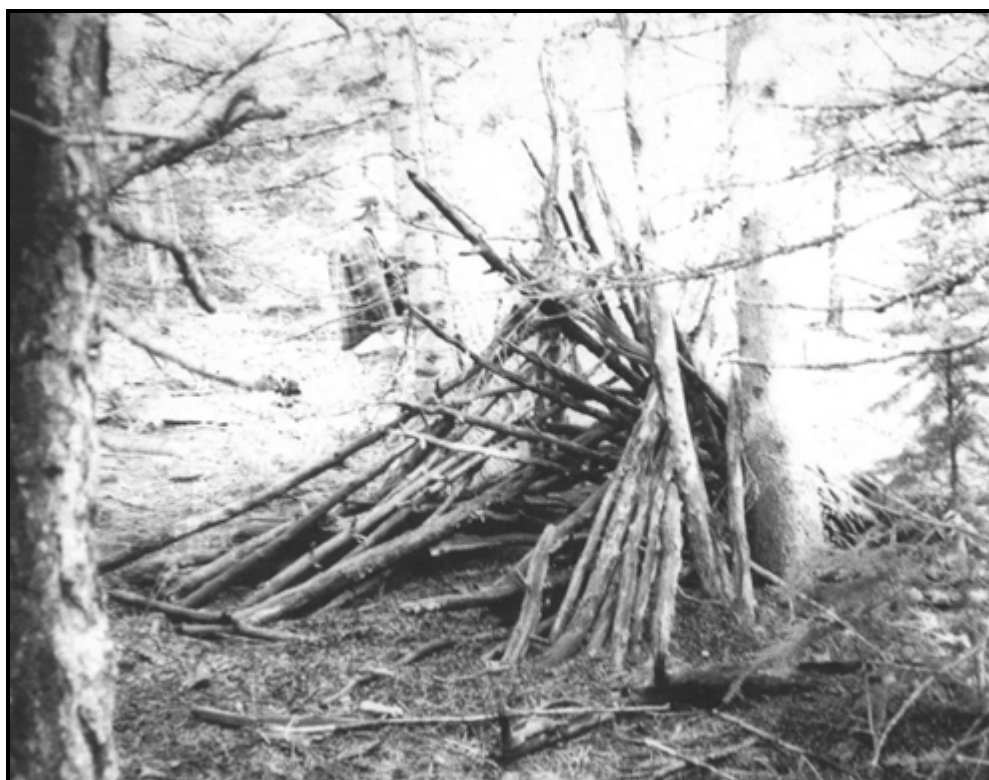
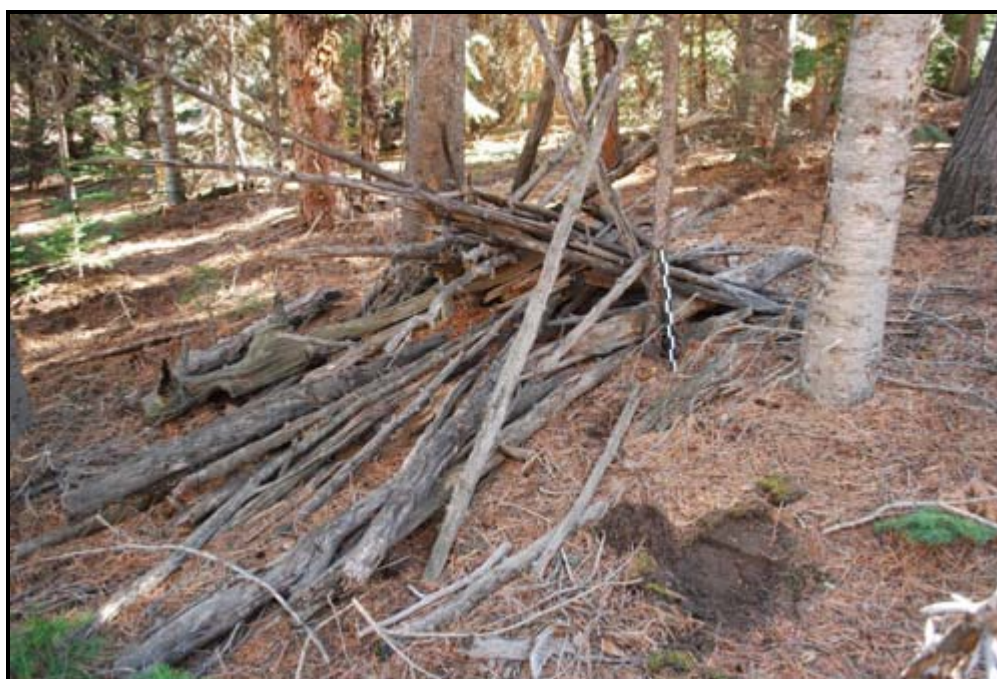
**Plate 2**

Top: 5LR4499 Feature 1, freestanding wickiup, taken in 1999, looking east.  
Bottom: 5LR4499 Feature 1 taken in 2011, looking east. Disturbed soil is location of metal excavation grid pin located by metal detection (Photo D1003, 1-51).

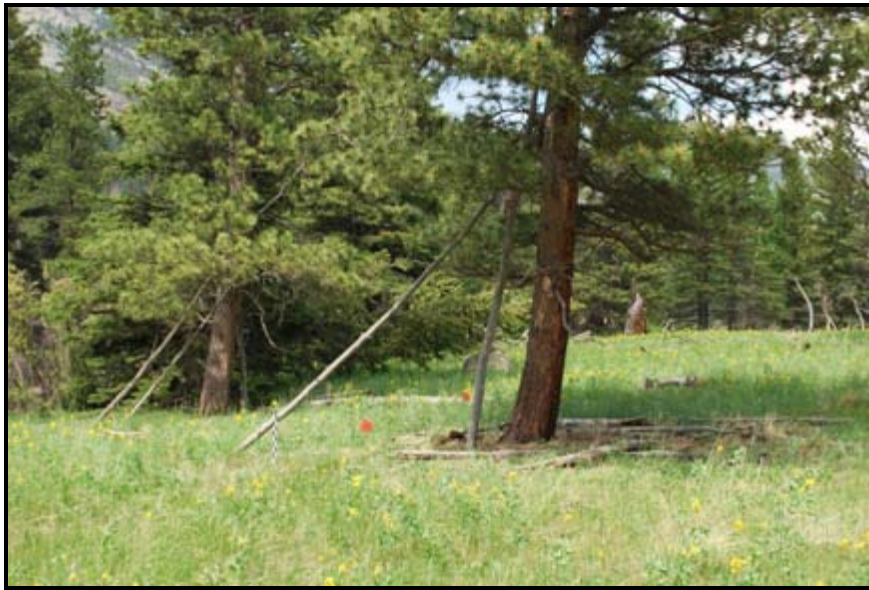
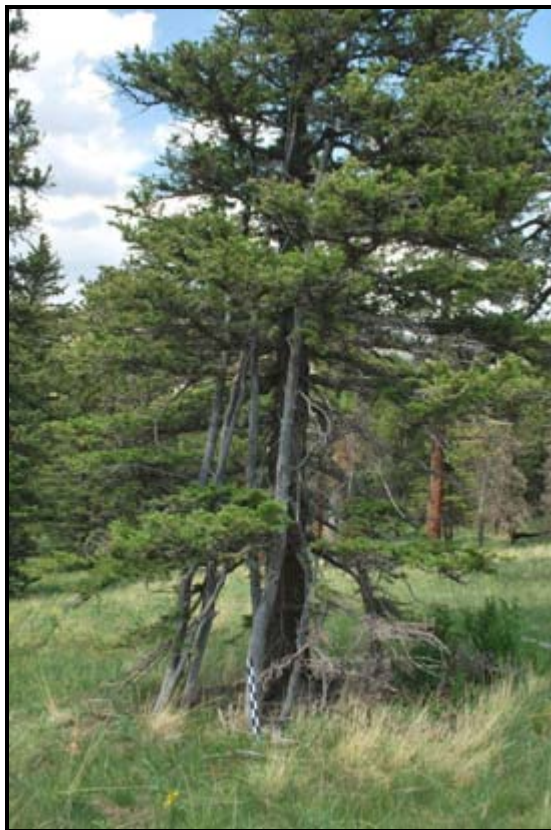
**Plate 4**

Bottom: 5LR4509 Feature 6, a “classic” cache of seven aspen poles, looking northeast. Note how the poles are placed close together and near to the tree trunk (Photo D1003, 3-31).

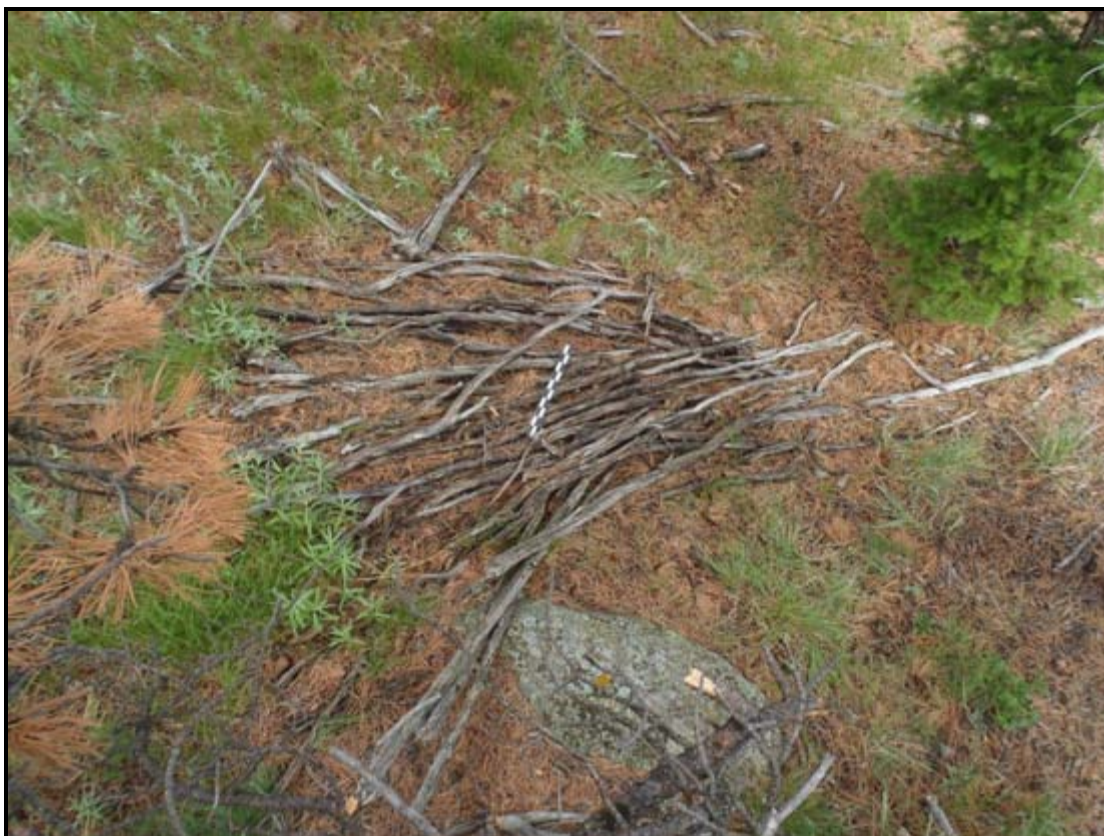
**Plate 5**

5LR4511, Feature 1, collapsed wickiup, looking north-northwest.  
Note how conical nature of wickiup is preserved in the pole configuration  
(Photo D1003, 5-73).

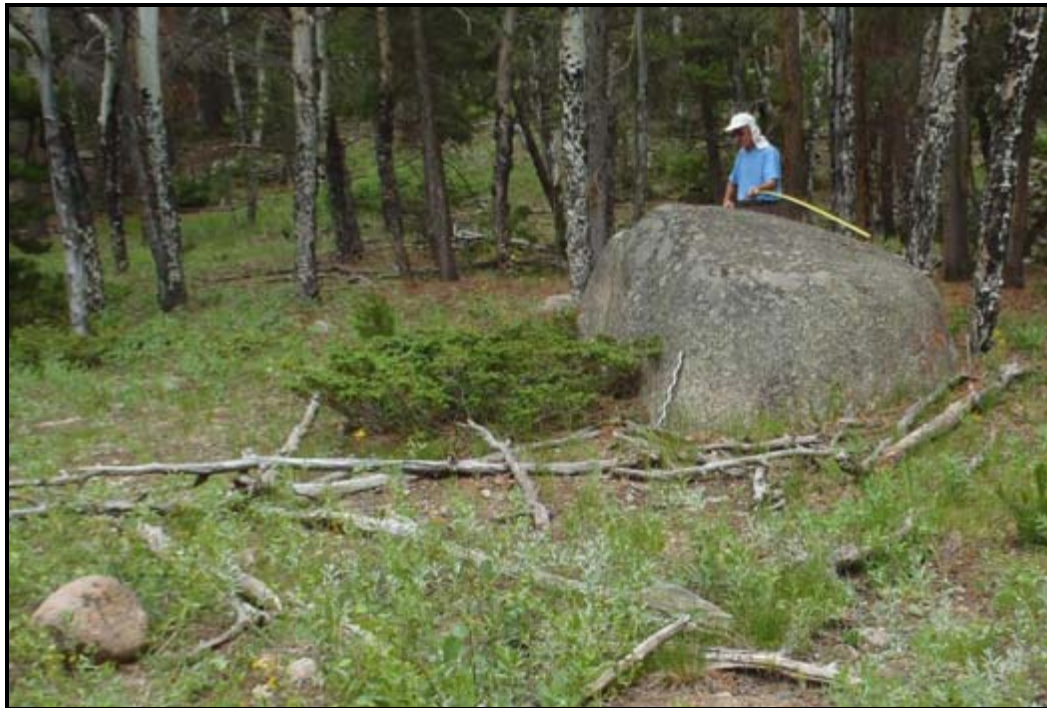
**Plate 6**

Comparison photographs of Feature 1, a boulder lean-to, at site 5LR4514 taken in 1999 (top) and 2011 (bottom), looking southeast. Note how the standing poles from 1999 have collapsed, scattered, and partially disappeared from the ground surface. (Photo D1003, 5-80).

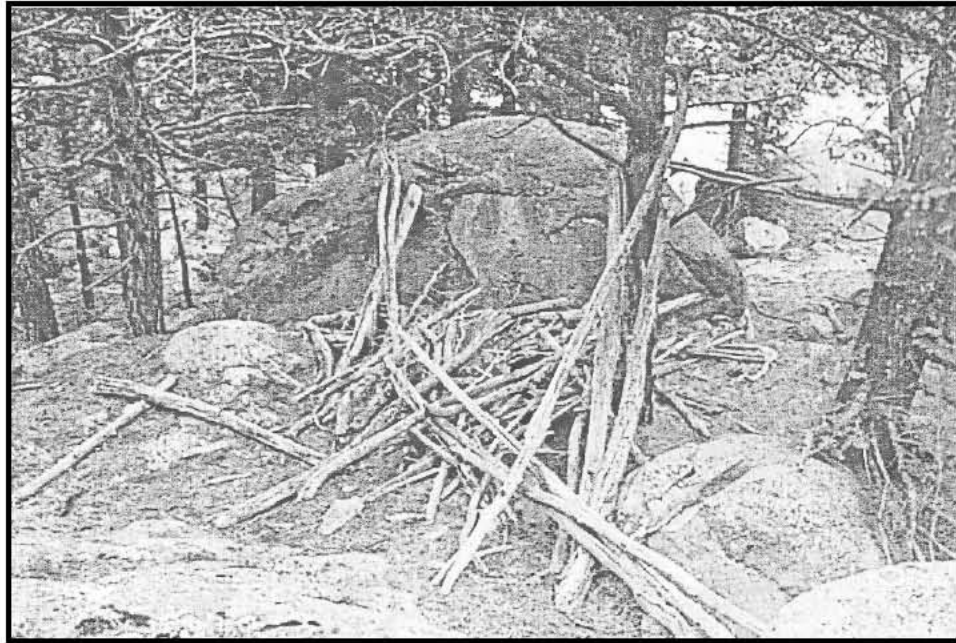
**Plate 7**

5LR4531 comparison photos. Feature 2, a modern windbreak, can be seen on the right in the 2010 photo (bottom). It was likely created from poles that were appropriated from Feature 1, what had originally been a boulder lean-to shelter, leaned against the rock to the left of center (see 1999 photo at top). Note ash scatter in front of the boulder that turned out to be a modern disposal of a human cremation. Photo is looking north-northeast (Photo D1003, 1-100).

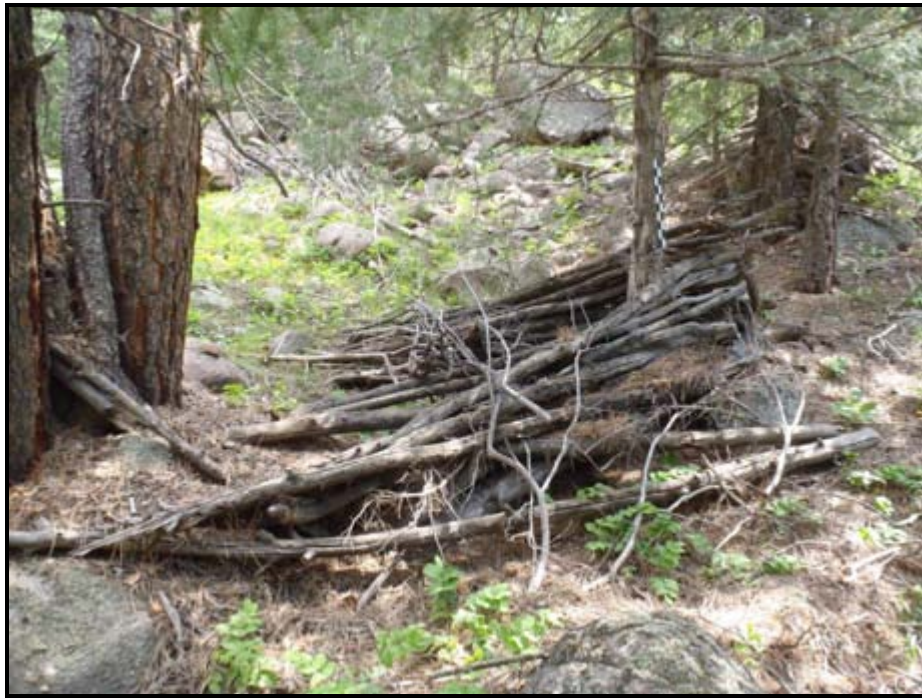
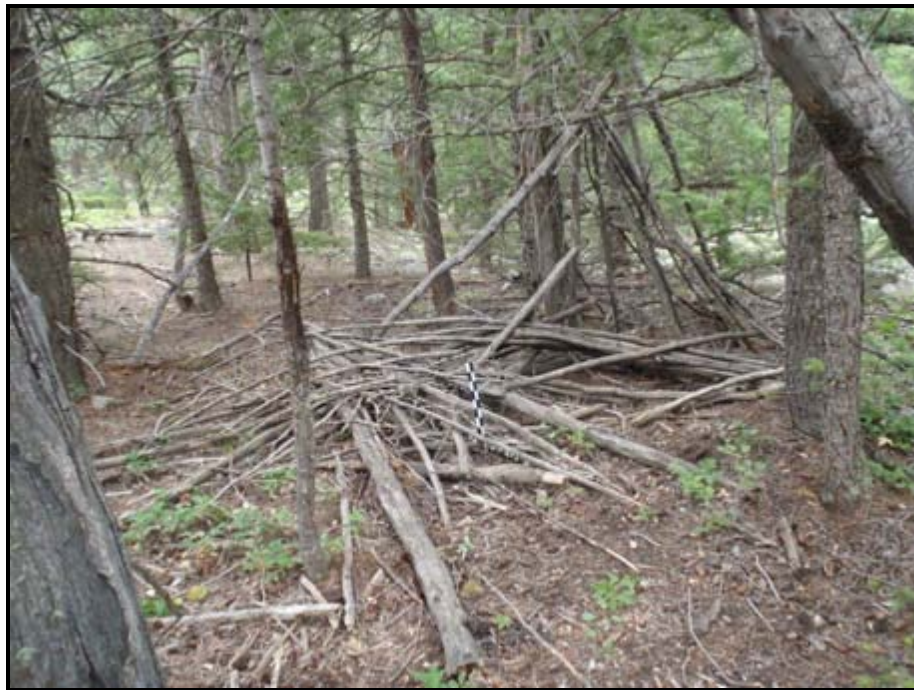
**Plate 8**

Bottom: 5LR4548 Feature 2, partially collapsed wickiup, looking southwest. (Photo D1003, 5-62).

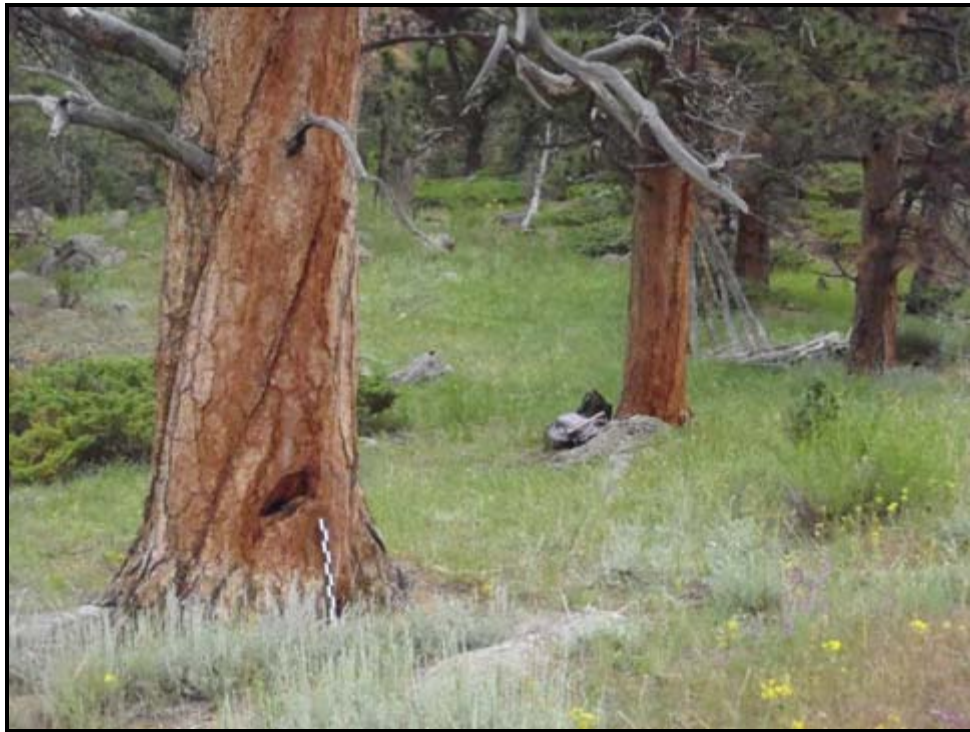
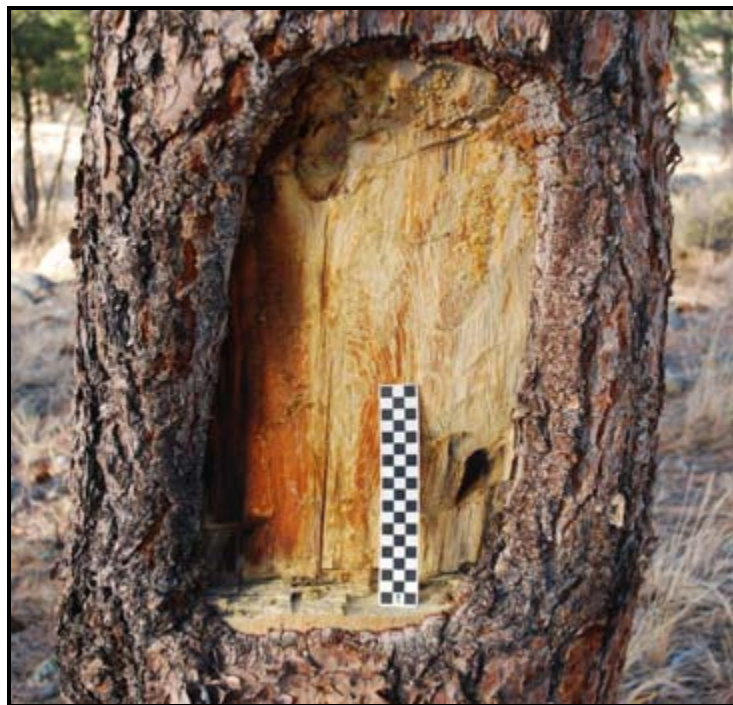
### Plate 9

Top: 5LR6962 Feature 2, culturally-modified ponderosa pine tree, is at left and Feature 1, pole cache is at right in background, looking north-northwest. (Photo D1003, 6-13).  
Bottom: 5LR12635 Feature 1, culturally-modified ponderosa pine, looking north. Note how feature is more typical of a Ute bark peel than the ax scar at 5LR6962. (Photo D1003, 1-45).

Feature 1 is a culturally modified ponderosa pine tree (Plate 9). The modification consists of a cultural bark peel typical of those known from Protohistoric Ute sites. Although the scar is not unlike a trail blaze, there is no trail nearby, and it is in an unlikely location to suggest that this were ever the case. The scar is situated on the south side of a mature ponderosa. It is at a height of 100cm to 147cm above the ground surface and measures 47cm in height and 27cm in width. The depth of the scar is 6cm. Metal ax scars are visible on the top and bottom of the scar and within the peel on the right side. One still-connected “chip” of wood from an ax cut appears to have been burnt.

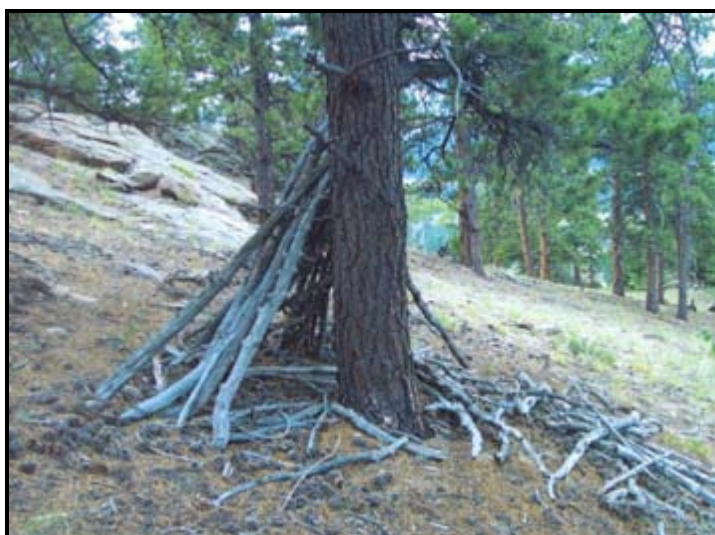
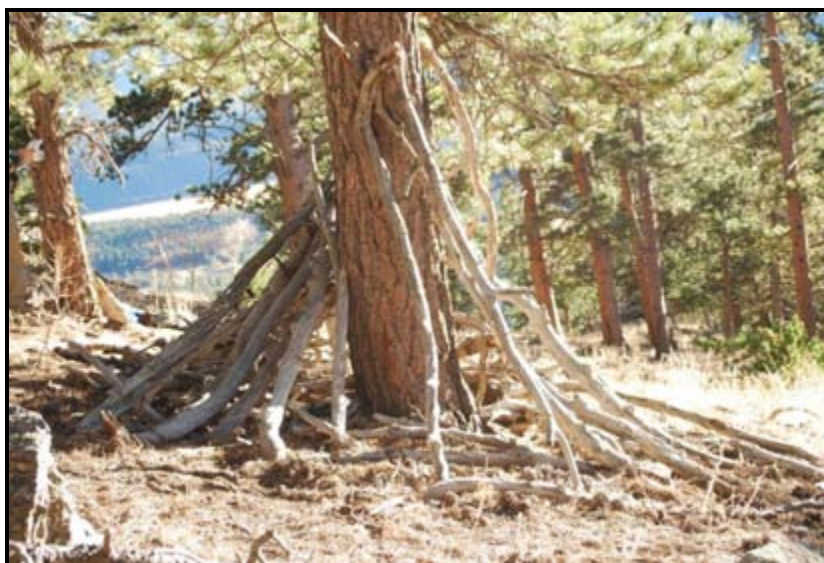
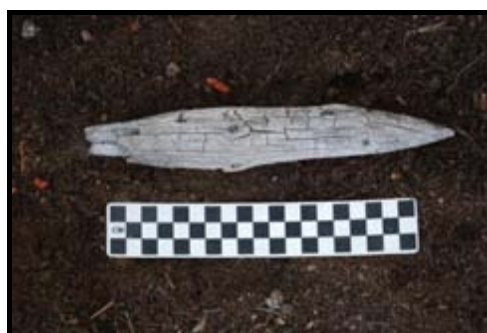
# **Plate 10**

Comparison photos of Feature 1 wickiup, site 5LR10229 taken in 2001 (top) and 2010 (center: Photo D1003, 1-10), looking south. Note how several of the collapsed poles in the earlier photo have been erected and rested against support tree. Bottom photo is whittled stick.

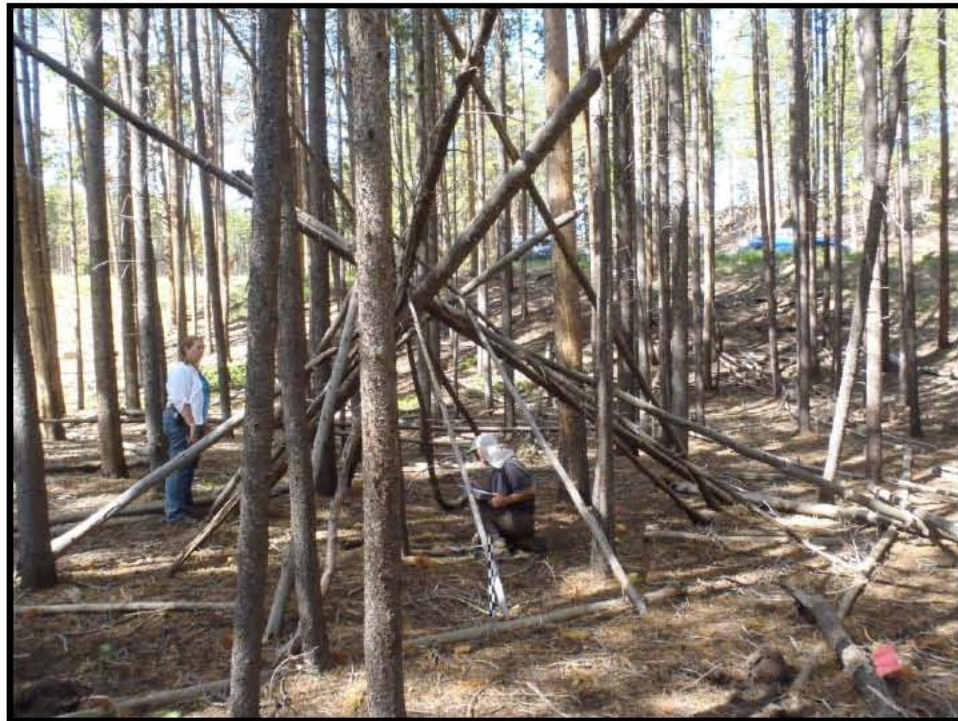
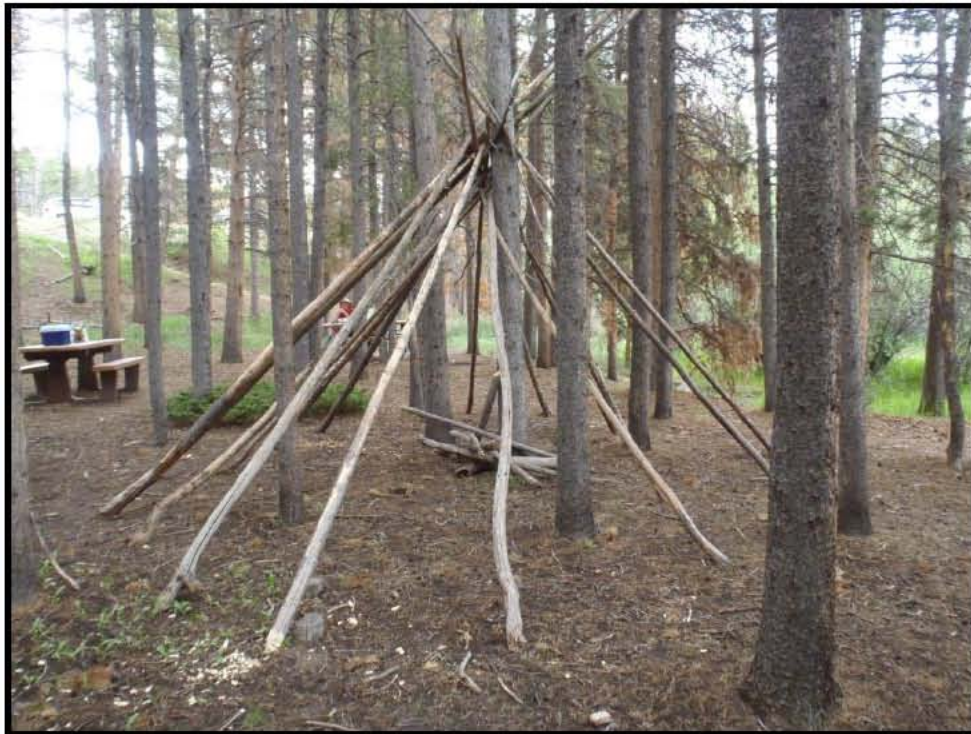
**Plate 11**

Photographs of two examples of the modern “tipi frames” that are being constructed by tourists in Rocky Mountain National Park (Photos D1003, 5-06 and 5-26). The structure in the bottom photo, according to a frequent park visitor, was not in existence in August of 2010.

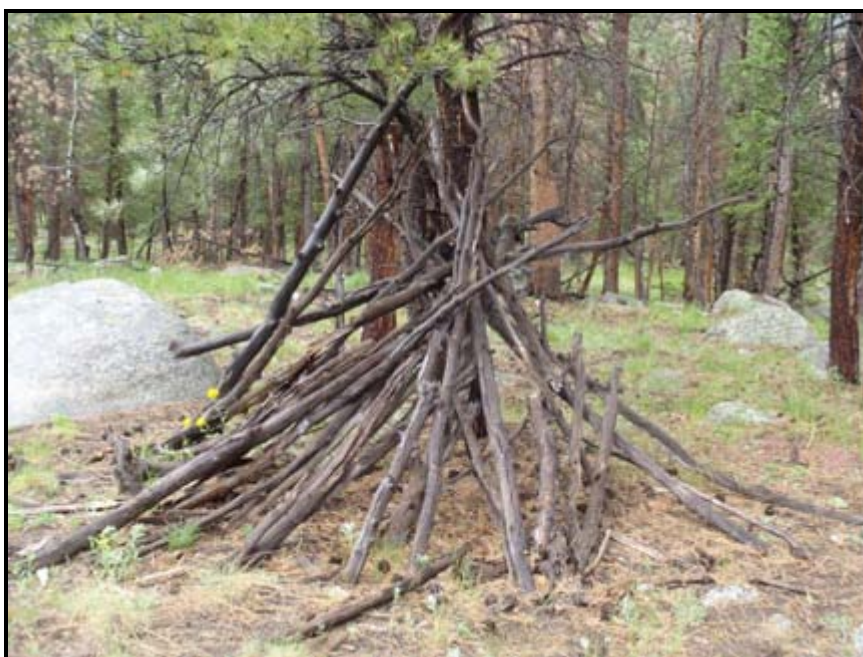
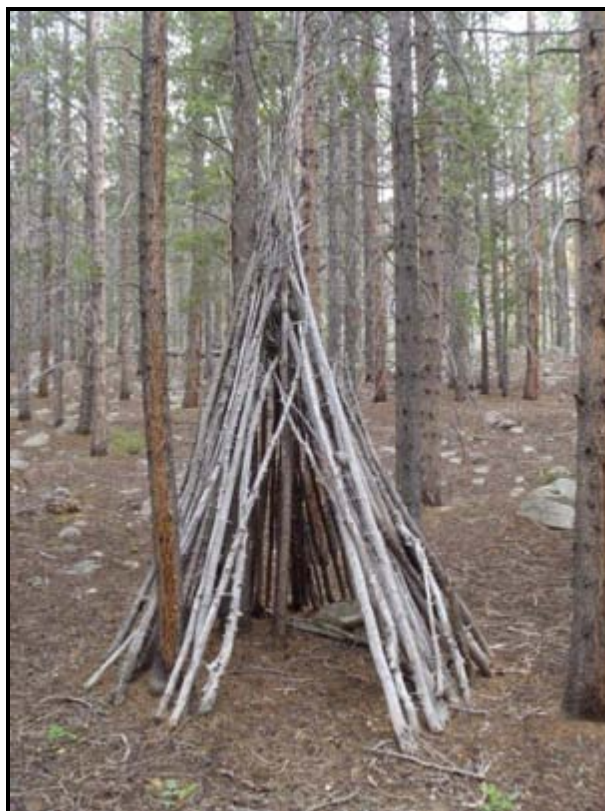
**Plate 12**

Bottom: 5LR12900, the Tea House Wickiup, looking northwest (Photo D1003, 5-38).

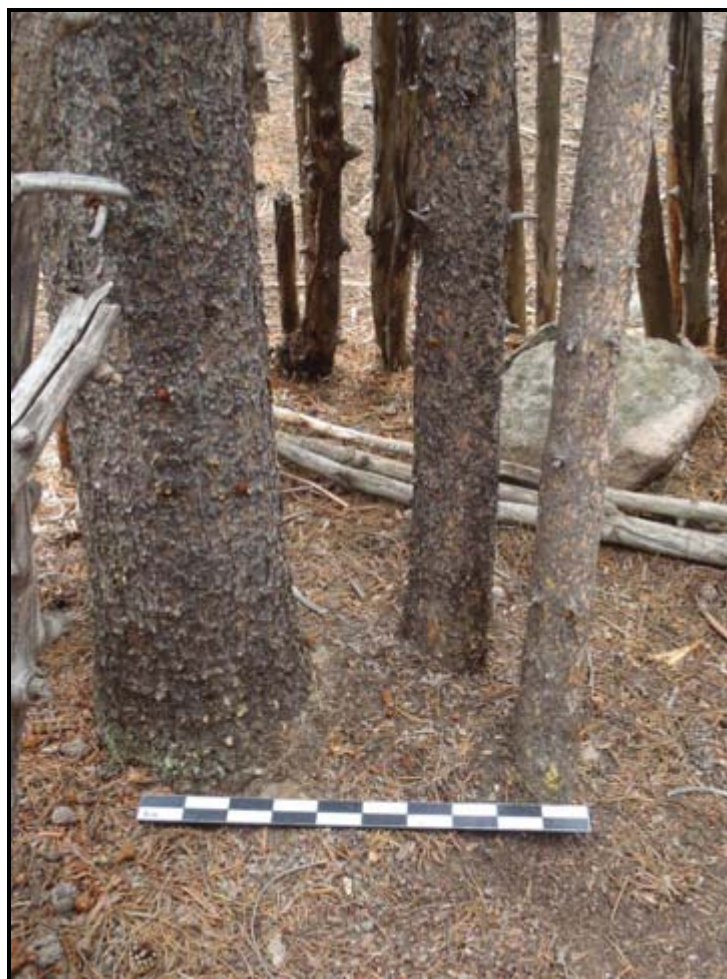
### Plate 13

Bottom: The interior of the wickiup showing three of the five pine trees that have grown up through the floor of the feature, looking north-northwest. Note the boulder and aspen sticks resting on the floor (Photo D1003, 5-89).

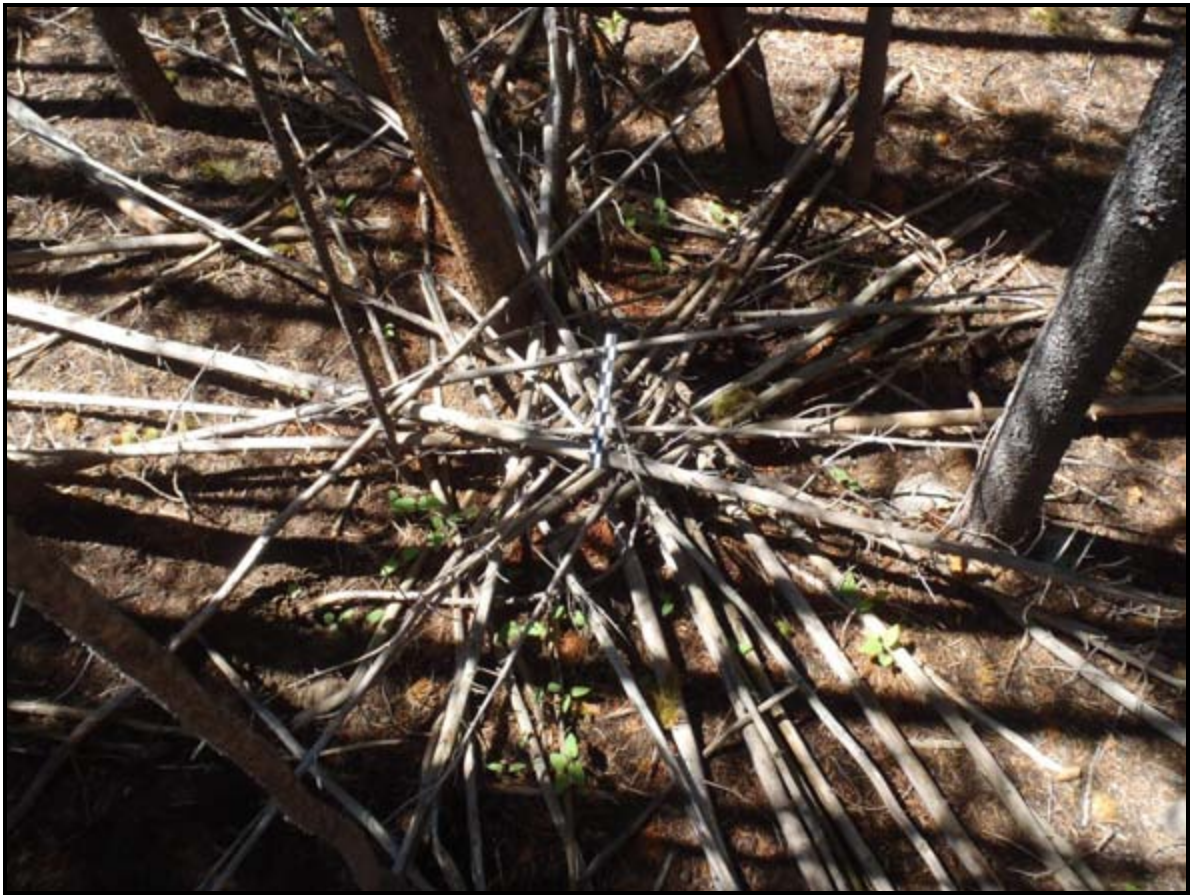
**Plate 14**

Feature 1 is a freestanding-style wickiup consisting of approximately 45 poles that have collapsed into a classic “wheel spoke” pattern on the ground, with all of the pole tips facing inwards and the butts to the outside (Plate 14). Notably, the poles are of lodgepole pine, as opposed to the more frequently encountered aspen pole wickiups in the Montane Life Zone. The diameter of the concentration of collapsed poles ranges from 5.3 to 5.7 meters in diameter—providing some estimate as to the original floor size of the shelter. The individual poles themselves range from 2.9 to 5.7m in length and from 3 to 6cm in mid-pole diameter. A gap in the fallen poles on the north-northeast side of the configuration suggests a possible location of the entryway at this point. A number of lodgepole pines have grown up through the collapsed poles, as well as in the immediate vicinity, however none of them appear to have been a support tree for the structure when it was standing.

5LR12903, Feature 1, collapsed wickiup, looking south. Note how the conical nature of the wickiup is preserved in the “wheel spoke” configuration of the collapsed poles (Photo D1003, 4-41).
